**DEPARTMENT OF TRANSPORTATION**

Contract #: 04-0120F4Cty: SF/ALA Rte: 80 PM: 13.2/13.9File #: 69.28**WELDING INSPECTION REPORT****Resident Engineer:**Siegenthaler, Peter**Address:** 333 Burma Road**City:** Oakland, CA 94607**Report No:** WIR-025506**Date Inspected:** 20-Jul-2011**Project Name:** SAS Superstructure**OSM Arrival Time:** 1900**Prime Contractor:** American Bridge/Fluor Enterprises, a JV**OSM Departure Time:** 700**Contractor:** Zhenhua Port Machinery Company, Ltd (ZPMC), Changxing Island **Location:** Shanghai, China**CWI Name:** Mr. An Qing Xing**CWI Present:** Yes No**Inspected CWI report:** Yes No N/A**Rod Oven in Use:** Yes No N/A**Electrode to specification:** Yes No N/A**Weld Procedures Followed:** Yes No N/A**Qualified Welders:** Yes No N/A**Verified Joint Fit-up:** Yes No N/A**Approved Drawings:** Yes No N/A**Approved WPS:** Yes No N/A**Delayed / Cancelled:** Yes No N/A**Bridge No:** 34-0006**Component:** Orthotropic Box Girder (OBG)**Summary of Items Observed:**

OBG Trial Assembly

Segment: 13 West

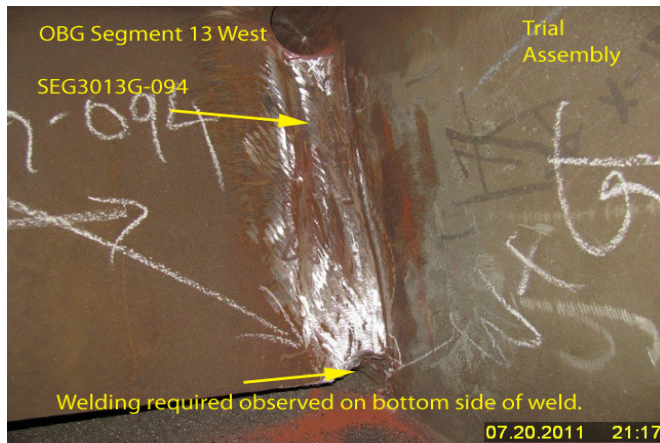
joint identified as SEG3013G-094 required some welding and grinding and SEG3013G-090 cope hole Profile required correct. This joint has been VT rejected because the weld need repair, For more information see below attached picture number 1.
